# Vehicle History Report

Chassis number <sup>1</sup>: GRF-006529

Make: SUBARU

Model: IMPREZA

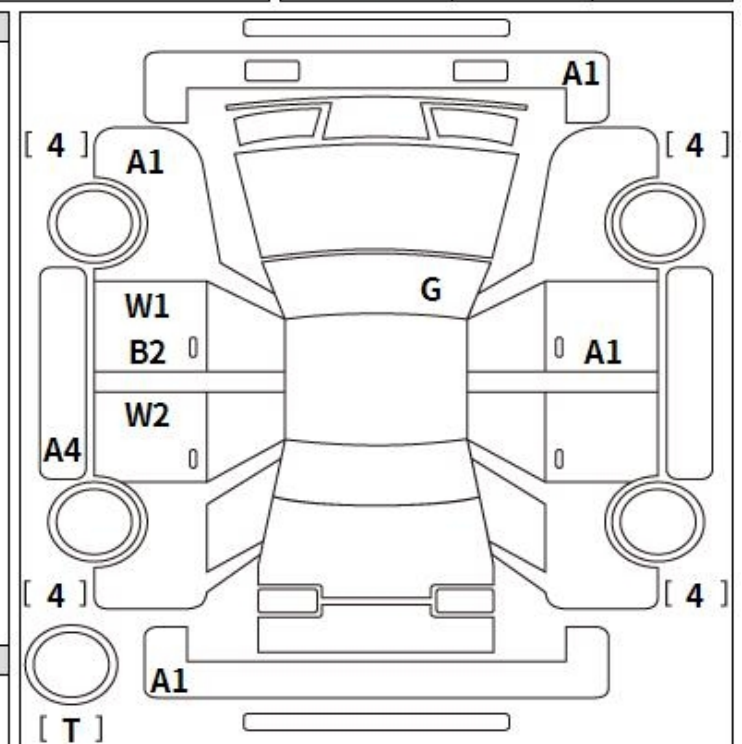
検査員記入欄
下廻りS 社外ハンドル ダッシュ板のり付 ピラー内張傷 ローダウン
事務局よりご案内
★★北陸サテライト会場出品車★★
